This final report presents the results of field monitoring and describes remedial measures to improve stability through the spring of 1980.

REPORT NO. FHWA/CA/TL - 80/27

LONG-TERM PERFORMANCE OF THE FIRST REINFORCED EARTH WALL IN CALIFORNIA

**FINAL REPORT
AUG, 1980**

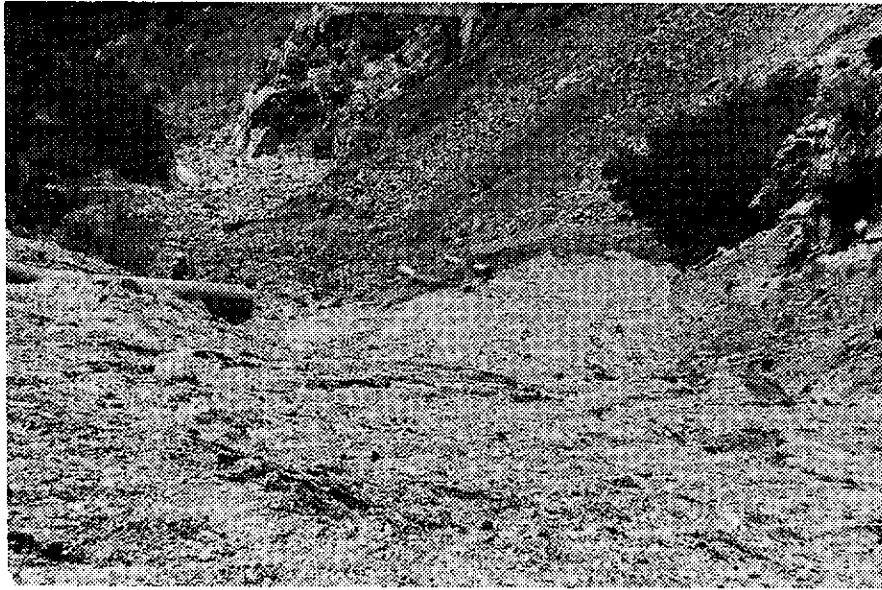
Photo 31 - Catchment Basin at Toe of Slope with
Retained Eroded Material, After One
Rainy Season (May 1980)

The fill slope below the wall is in generally good condition with some surface erosion (Photos 29 through 31), most of which has occurred at the south end of the wall below a rock outcrop. Erosion is concentrated in this area due to surface water runoff over the rock face.

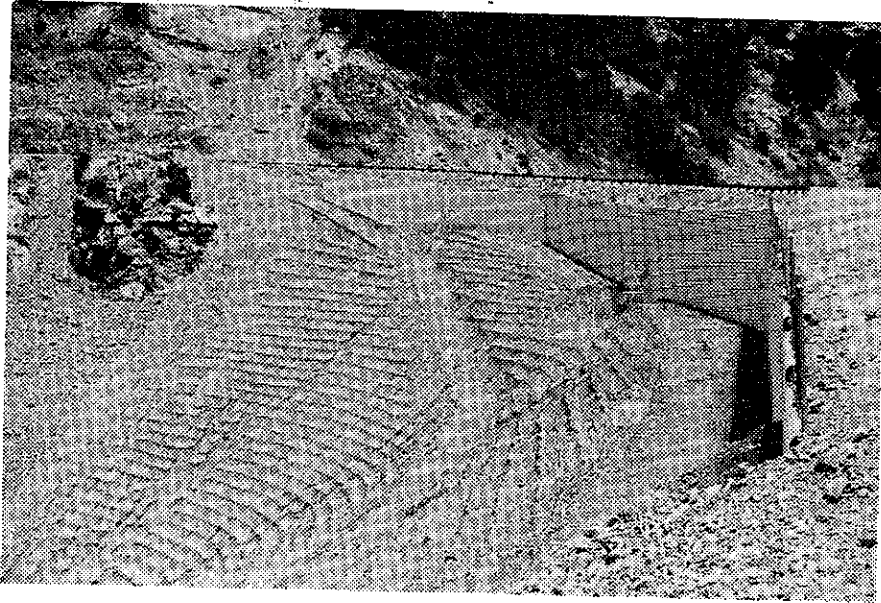
Photo 29 - Side View of Wall Looking North at
Access Road on Slope, After One
Rainy Season (May 1980)

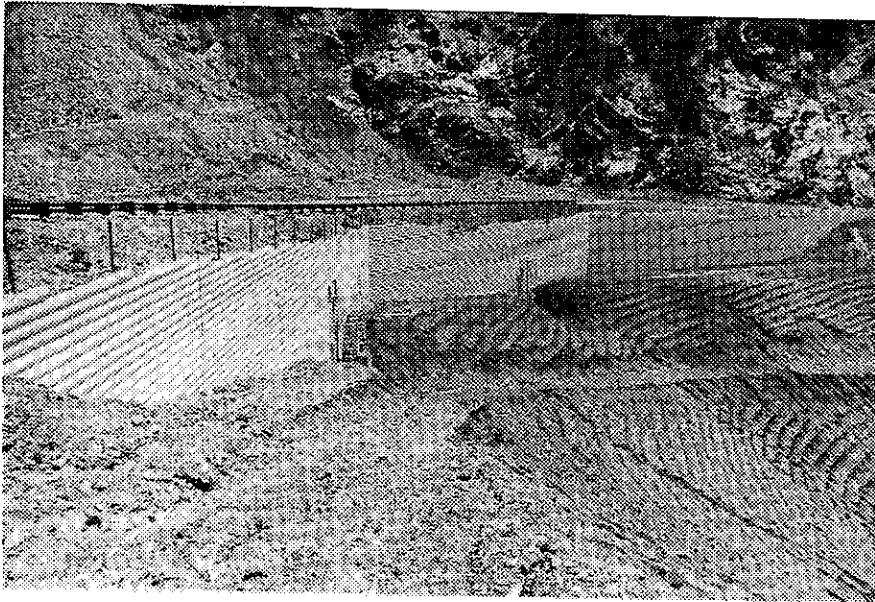
Photo 30 - Side View of Wall Looking South at
Access Road on Slope, After One
Rainy Season (May 1980)

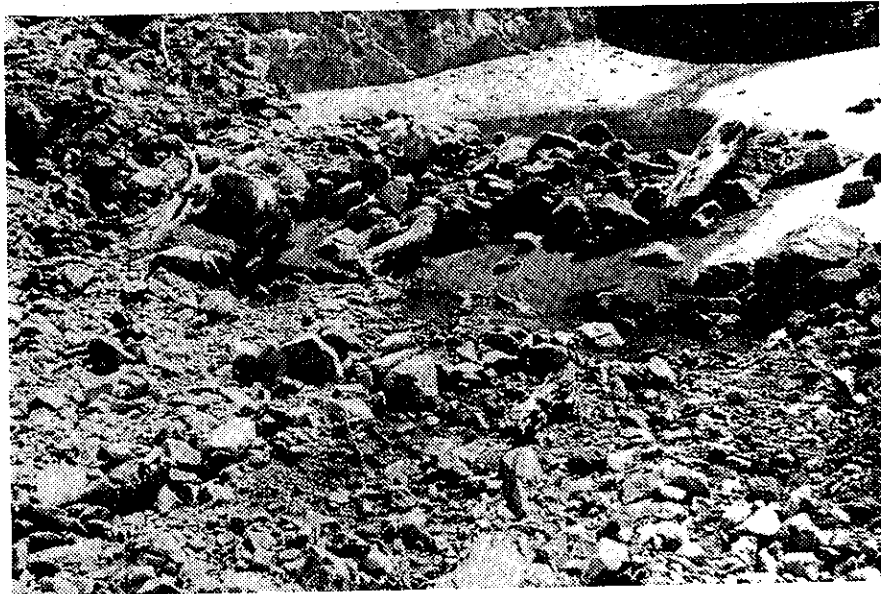
Photo 27 - Water Flowing into Drainage Channel
Behind Wall and Disappearing Rapidly
into Pervious Channel (June 1980)

A final condition survey was obtained on June 12, 1980. It was noted that an estimated stream flow of about 5 gal./min. of water was coming down the slope behind the wall and entering the upper portion of the drainage channel (Photo 27). This flow disappeared into the channel about 3 ft. beyond a concrete lined approach apron. It was apparent therefore that the drainage correction was not completely satisfactory since none of this flow was reaching the culvert inlet. However, the drainage facility was in excellent condition considering the 35 inches of rainfall that occurred this past winter season since the channel was repaired.

A contract to seal the drainage channel behind the wall and prevent infiltration of surface water that would lead to additional seepage pressure on the wall was completed in December 1979.

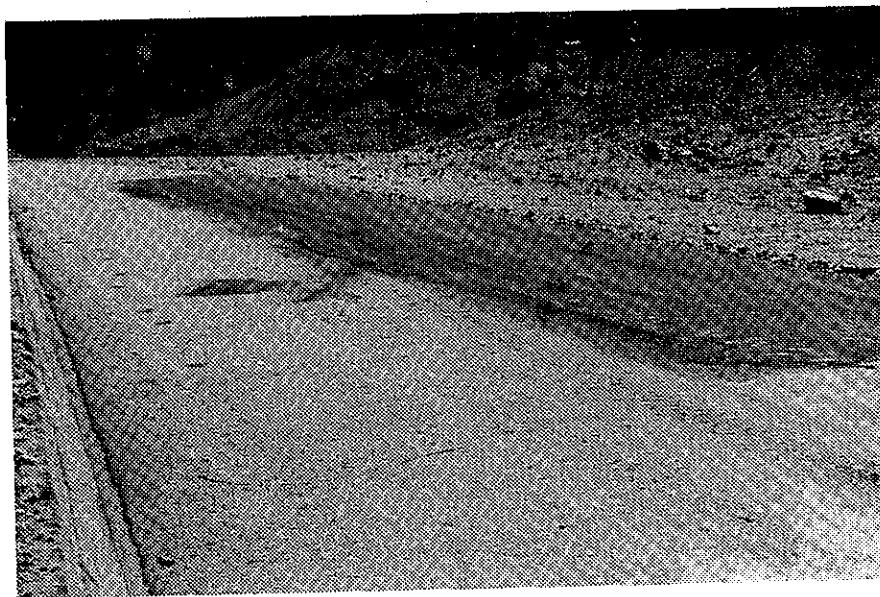
Photo 28 - Patched Pavement Behind South Flank
of Wall (June 1980)

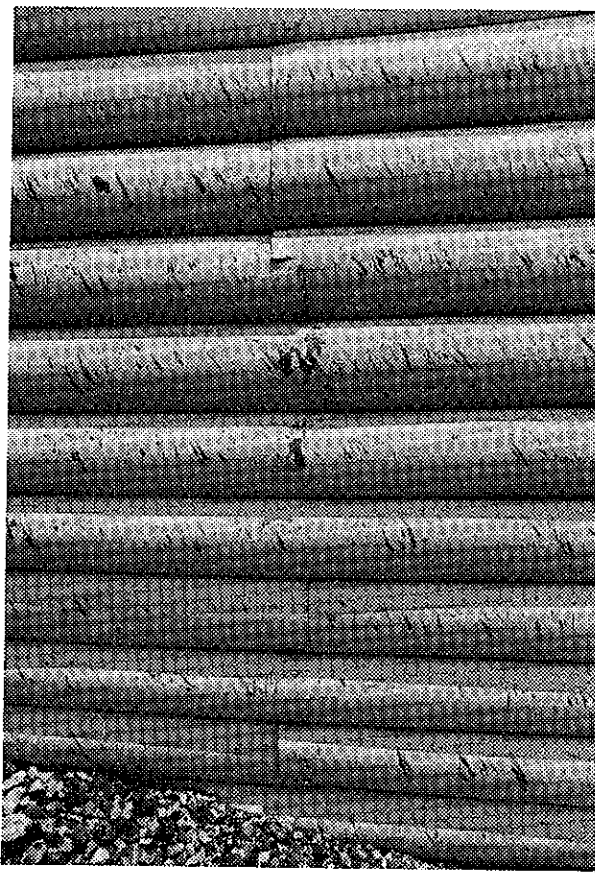
Photo 25 - Close-up of Skin Plate Joint Compression in Center Chord (May 1980)

Photos 25 and 26 show the effects of the tremendous axial compressional forces that have been experienced by the center chord of the wall due to a buildup of lateral forces as the wall has moved outward. Note the distortion and gouging of end plates that has occurred. (Refer to skin element numbers 8, 25 and 43 in Tables 7 and 8.)

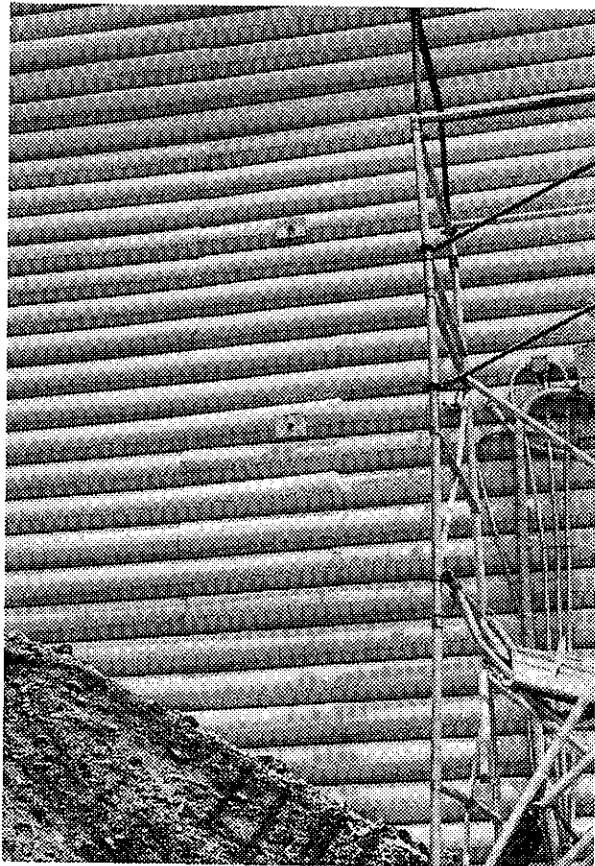
Photo 26 - Evidence of Skin Plate End Gouging and Distortion Near Instrumentation Station 551+75, Center Chord (May 1980)

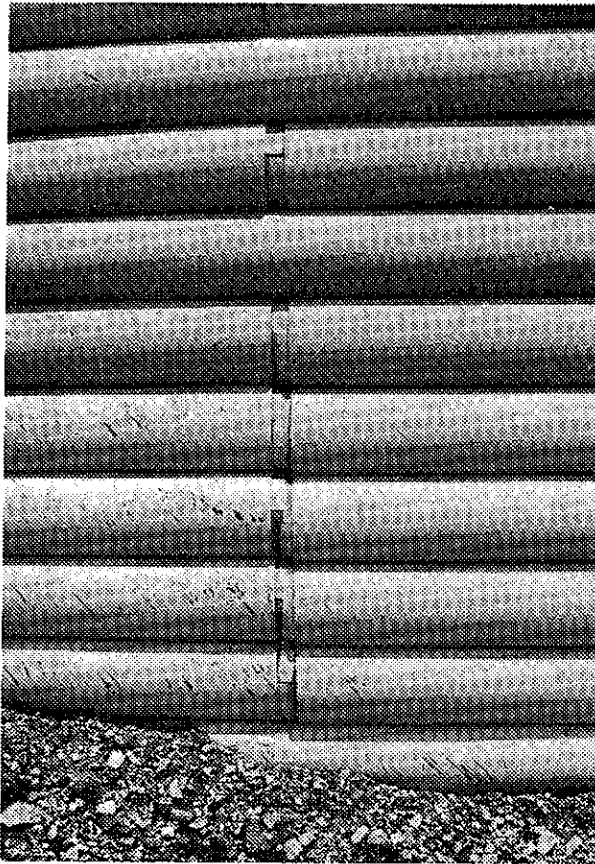
Photo 23 - Close-up of Skin
Plate Joint Separation on
North Flank (May 1980)

The relative magnitude and direction of movement of the wall has been manifested in the steel face elements as shown by photographs taken June 28, 1980. Photos 22, 23 and 24 show the extension and separation at the joints between skin plates on the north flank due to axial tensile stresses in the face. (Refer to skin element numbers 46, 57 and 69 in Tables 7 and 8.) This condition also occurs but to a lesser extent at the end of the south flank.

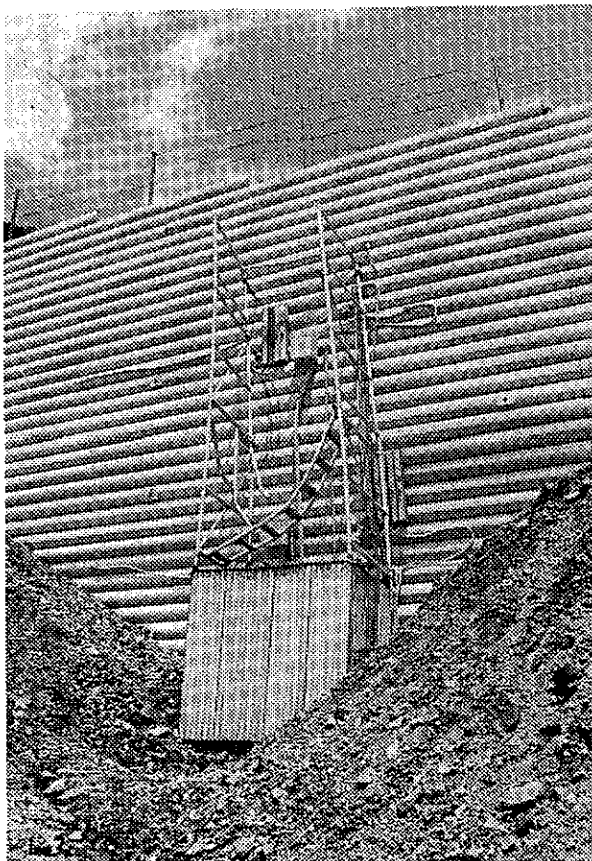
Photo 24 - Skin Plate Joint
Separation Near Instrumenta-
tion Station 550+25, North
Flank (May 1980)

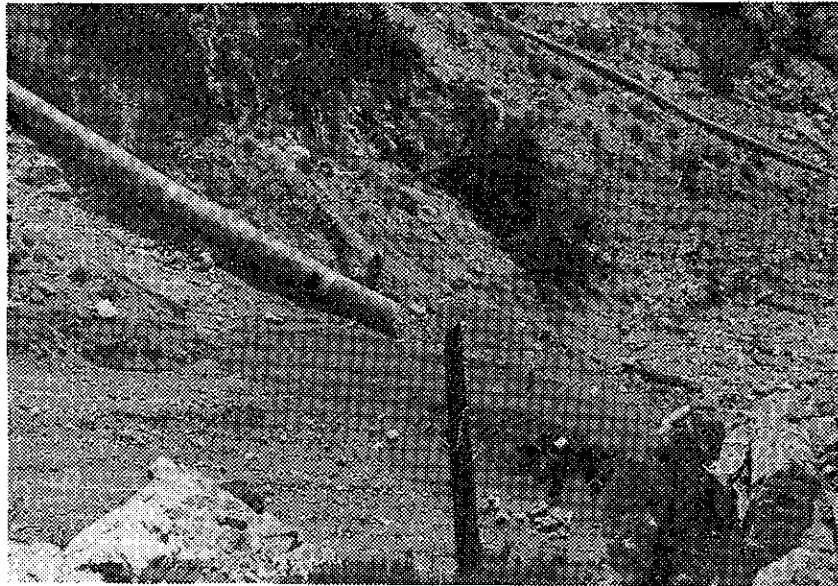
Photo 21 - Catchment Berm at Toe of Slope
to Retain Eroded Material
(August 1979)

The earthwork resloping operation below the wall was completed on August 7, 1979 by the Foothill Maintenance Station using Day Labor. This work involved: removing the temporary buttress and raising the berm in front of the wall toe by 10 feet as recommended (Photo 17); resloping the embankment (Photo 18); restoring the 84-inch drain pipe (Photo 19); constructing the access road from the top of the embankment to the toe of the slope (Photo 20); and building a catchment berm at the toe of the slope (Photo 21). The completed slope was terraced to minimize future erosion.

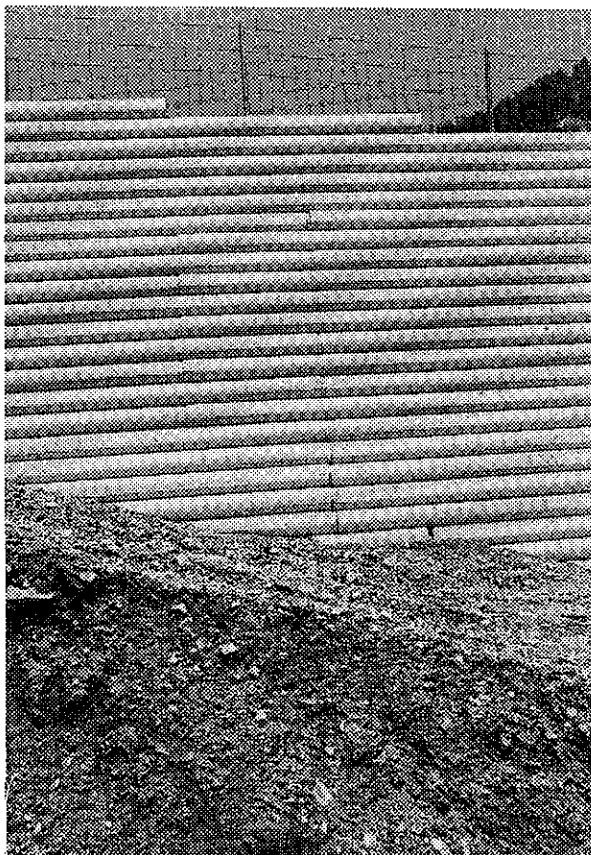
Photo 22 - Extension and
Separation of Skin Plate
Joints on North Flank
(May 1980)

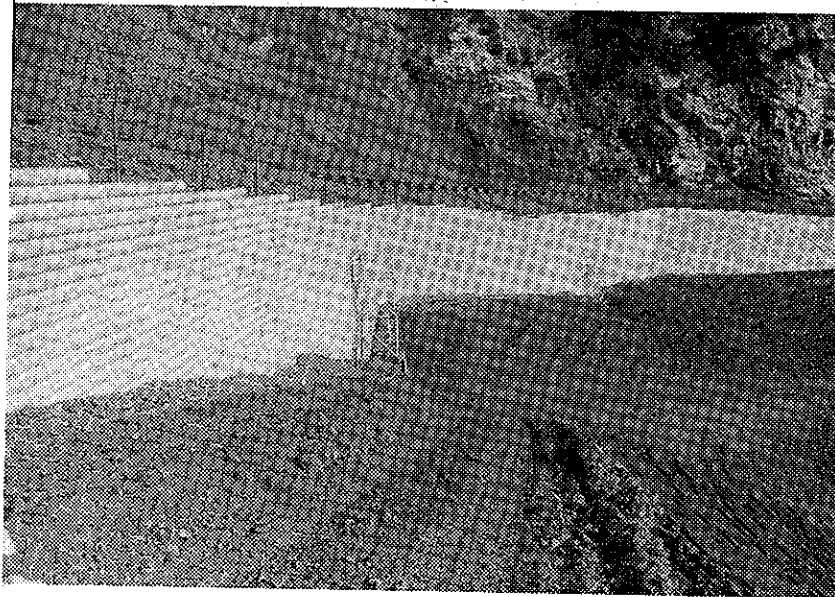
Photo 17 - Resloping and Construction of 10 ft of Additional Toe Buttress (July-August 1979, note stain on wall face of south flank from temporary buttress.)

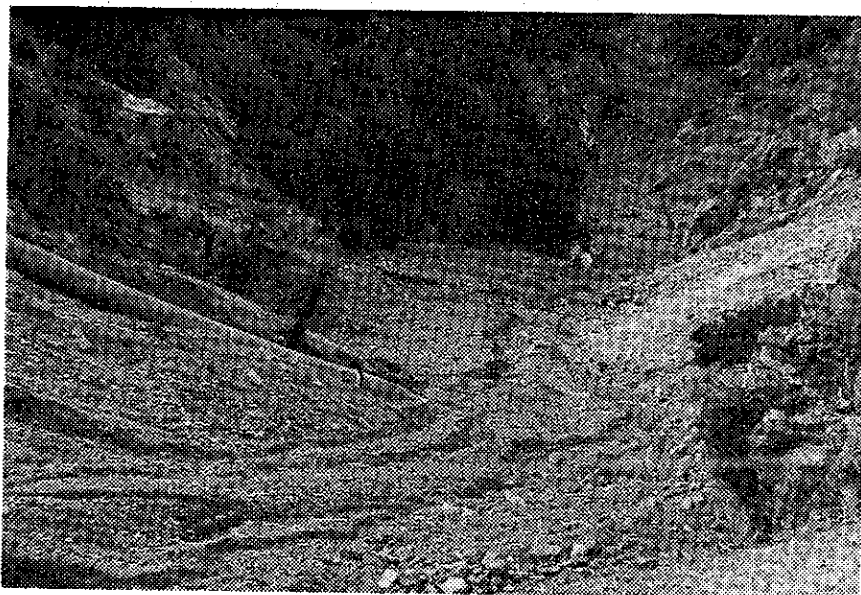
Photo 9 - Erosion at Toe of Slope Below
Wall (June 1978)

The primary area of concern was along the south flank where strain gage instrumentation and reference points indicated continuing outward movement. Approximately 50,000 cu. yds. of material were pushed over the wall face and down the slope during November and December 1977 (Photo 7). This remedial measure provided temporary buttressing through the winter of 1977 at a fraction of the cost for the proposed engineered (compacted) slope correction. However, during the winter of 1977-1978, erosion occurred on the temporary buttress which steepened the slope and based upon a stability analysis reduced the factor of safety (Photos 8 and 9).

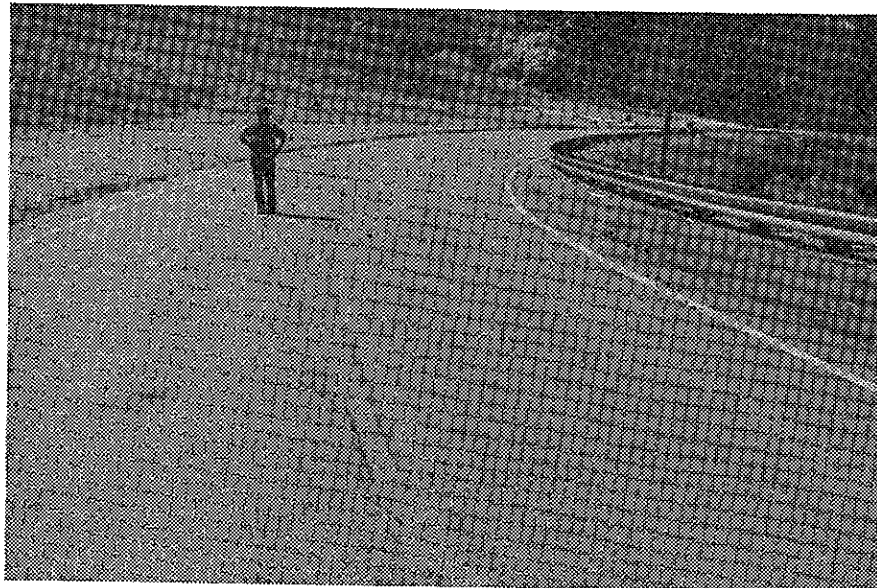
Photo 10 - Cracks in Pavement at North Flank
of Wall Near Centerline (June 1978)

A crack count made during the final condition survey indicated several 1/4 to 3/8 inch wide cracks in the pavement behind the north flank of the wall. These are shown in Figure 14 and are the same cracks observed in 1978 (Photo 10). Hairline cracks were also observed in the patched pavement area behind the wall's south flank (Photo 28). These cracks were reflecting up from the interface between the patch and the old pavement. The pavement and roadway above the wall are otherwise in excellent condition.

centerline for a distance of about 40 feet (Photo 10). It was apparent that reshaping of the slope below the wall would be mandatory prior to the next winter season. Recommended remedial measures by the Transportation Laboratory to improve wall stability were submitted to District 07 in October 1978. These measures included flattening the embankment slope, interception and diversion of surface runoff and removal of additional slide debris behind the wall plus repair of the drain system below the wall.

During this period, a series of cracks appeared in the pavement on top of the north flank of the wall near roadway

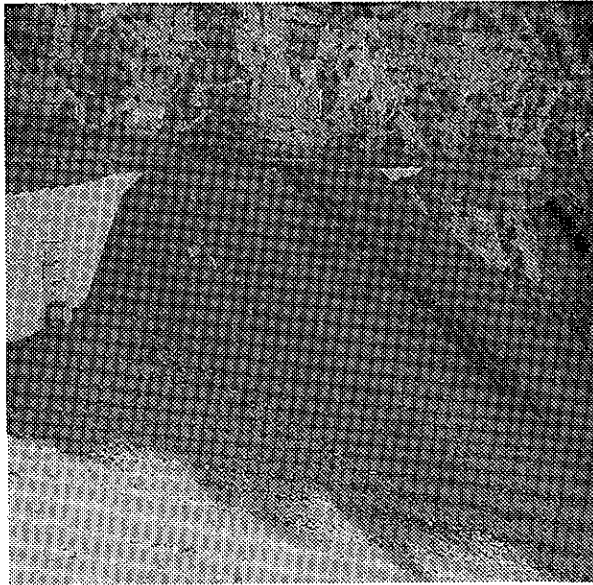
Photo 7 - Slide Material Being Pushed Over
Wall Face to Form Temporary Buttress
(November-December 1977)

prior to the winter storms. It was proposed that maintenance forces using rented equipment and Day Labor place a temporary buttress in front of the wall by pushing slide debris over the top and allowing the debris to form its own slope. This procedure was necessitated by lack of access to the base of the wall. Consequently, material had to be placed uncompacted.

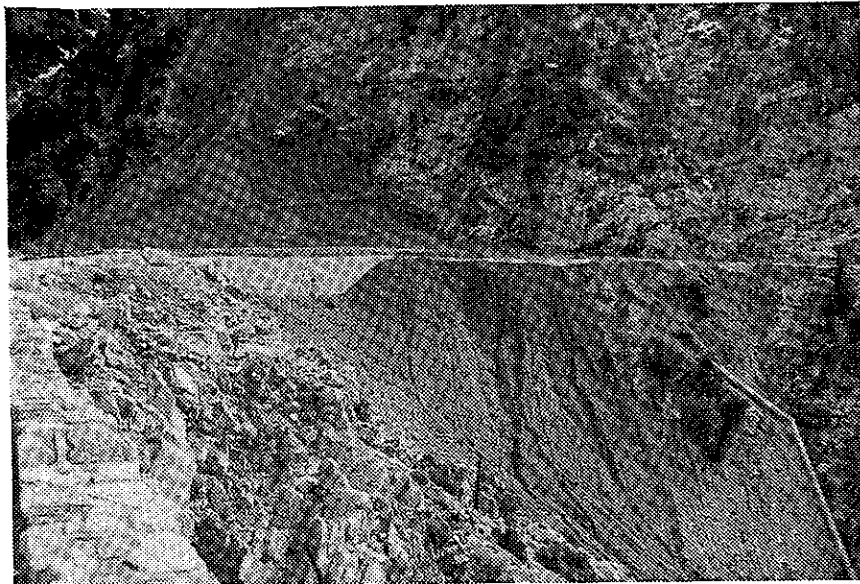
Photo 8 - Erosion on Temporary Buttress
(Winter of 1977)

Seepage through the embankment below the wall and storm water runoff over the wall and down the slope face also contributed to severe erosion of the toe buttress and the embankment slope below the wall's south flank. The mud flow which occurred in September 1976, went completely over the roadway and deposited large amounts of slide debris above the wall and spilled some over the top. The resultant embankment slope up to the base of the wall along the south flank was approximately 1.5:1 following the winter storm of 1976, as opposed to the constructed slope of 1.75:1 which was still intact for the remainder of the wall. This erosion and sloughing reduced the available lateral support considerably.

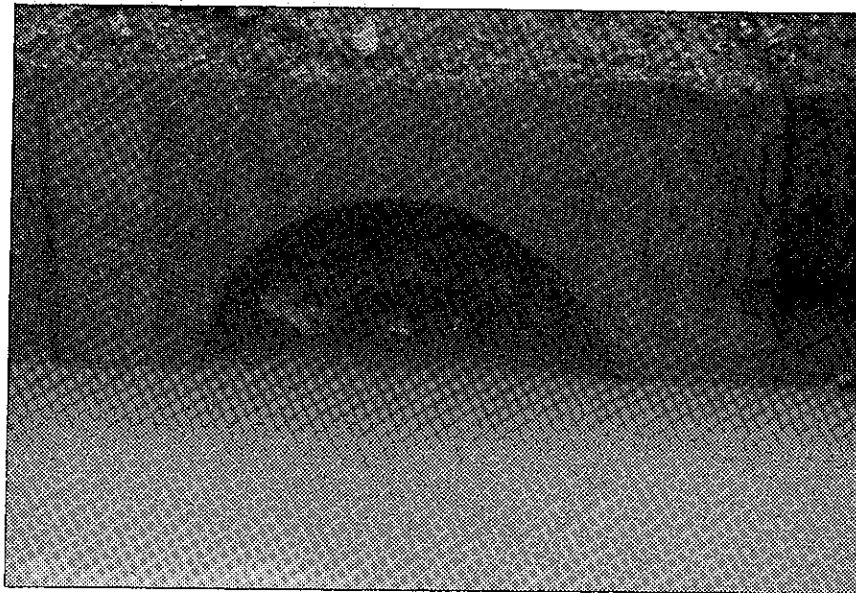
Photo 5 - Plugged Culvert Inlet During
Winter Storm

to surface water moving directly into the highly permeable embankment from natural drainage swales in back of the wall, when these flows were unable to reach the culvert inlet (Photo 4) or due to a plugged inlet structure (Photo 5).

1. Improve surface drainage at the inlet to the existing 84 inch CSP and seal the ponding area to preclude percolation through the reinforced embankment. The seal could be placed and protected with about two feet of fine-grained relatively impermeable soil. Provisions would also be made to directly intercept two drainage channels which were discharging directly into the ponding area.
2. Mud flow debris between the roadway and the wall, and also to the east of the wall were to be removed to lessen the load on the wall (Photo 6). The debris material could be used to flatten the existing eroded slope below the south flank of the wall and raise the height of the buttress at the wall base which would provide increased lateral resistance to movement.

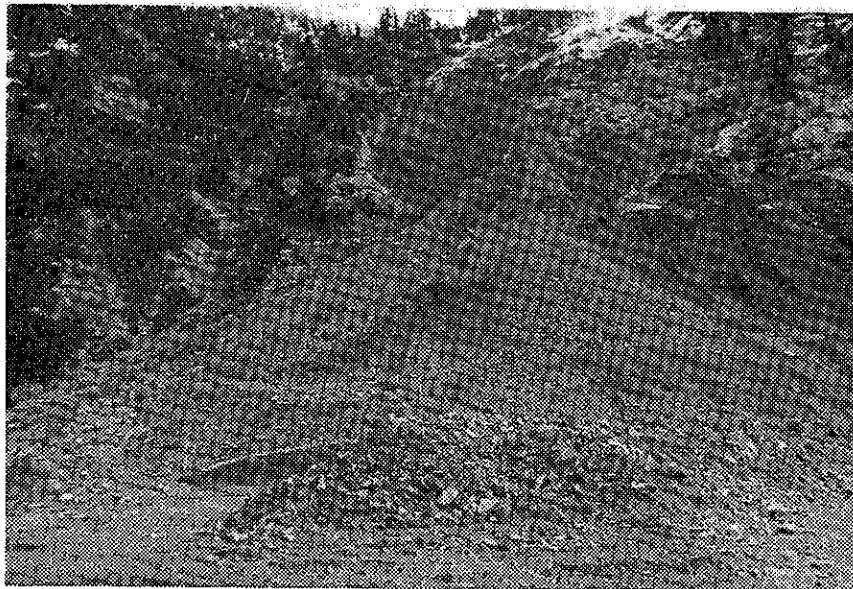
Photo 6 - Slide Debris Prior to Removal
Behind Wall

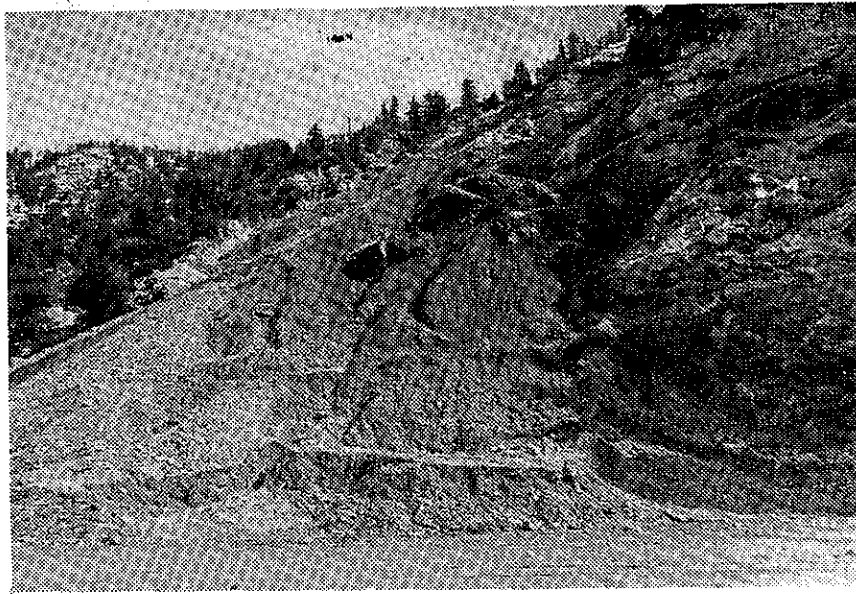
Photo 3 - Continuous Accumulation of Slide
Debris Behind Wall

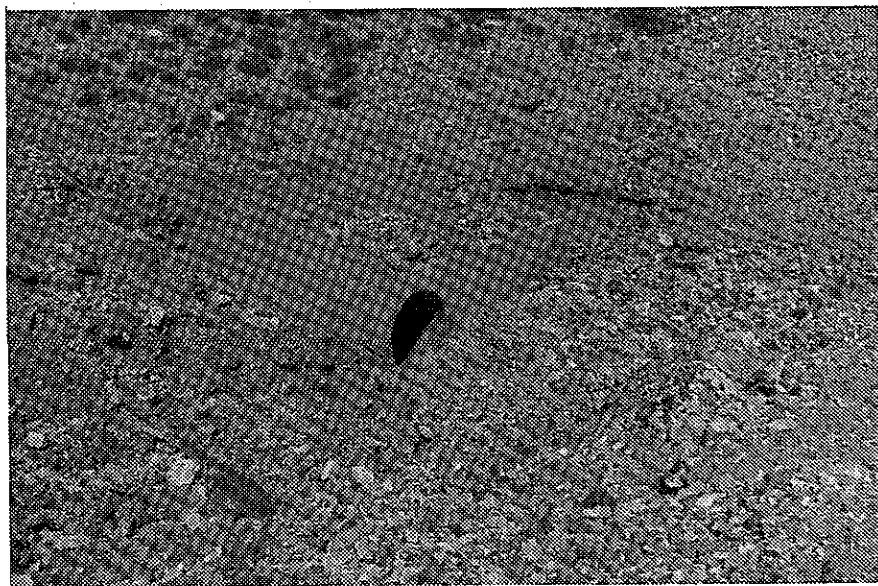
Photo 4 - Culvert Inlet Behind Wall (Note
pervious nature of channel
entrance.) - June 1978

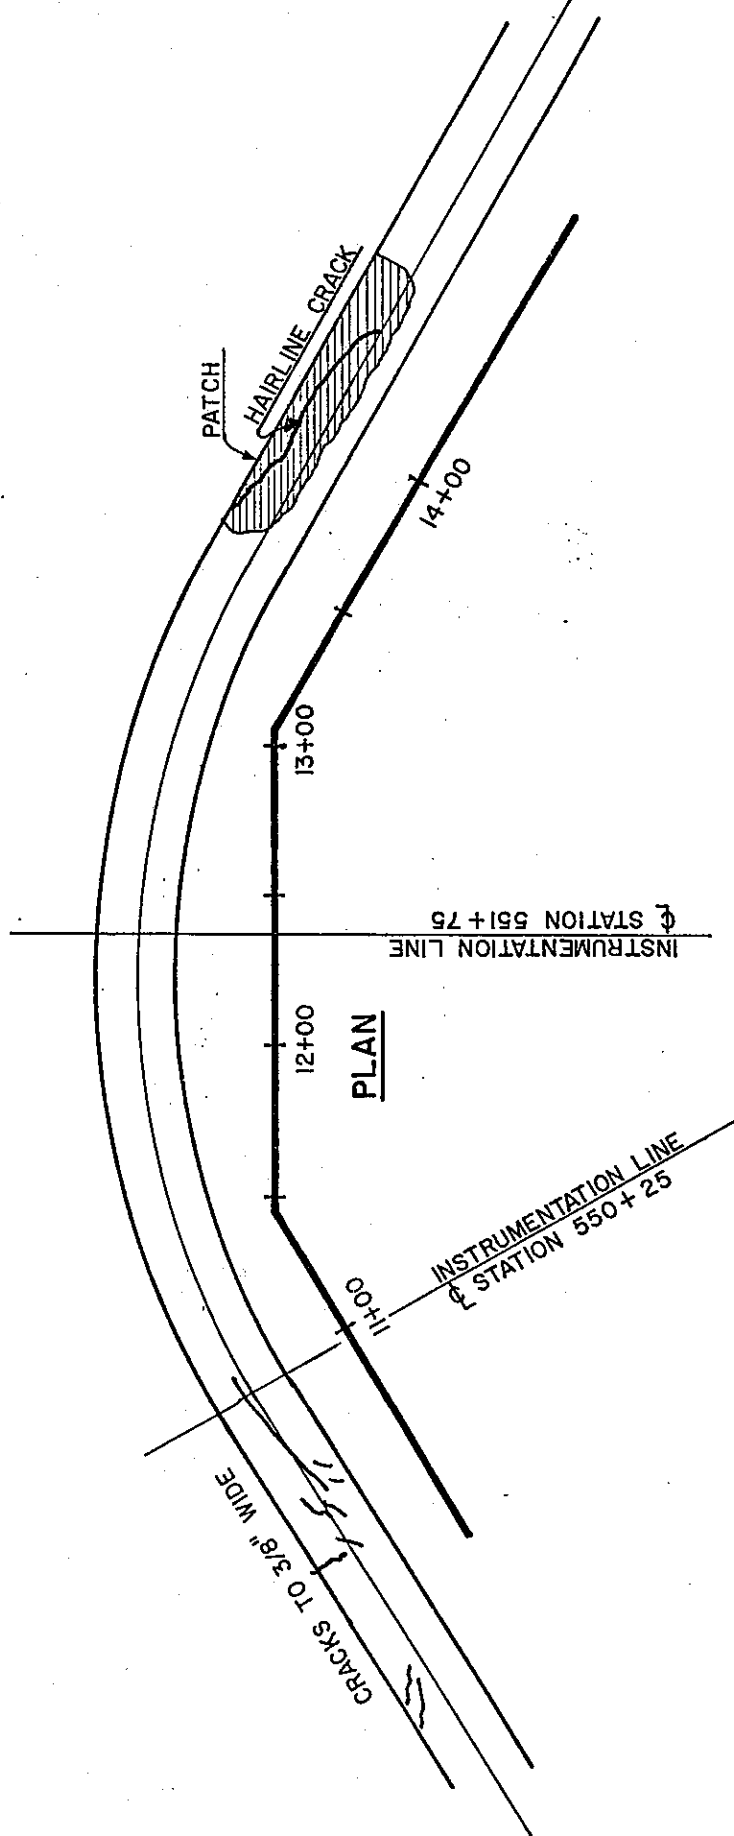
FIGURE 14

PAVEMENT CONDITION STUDY, JUNE 1980

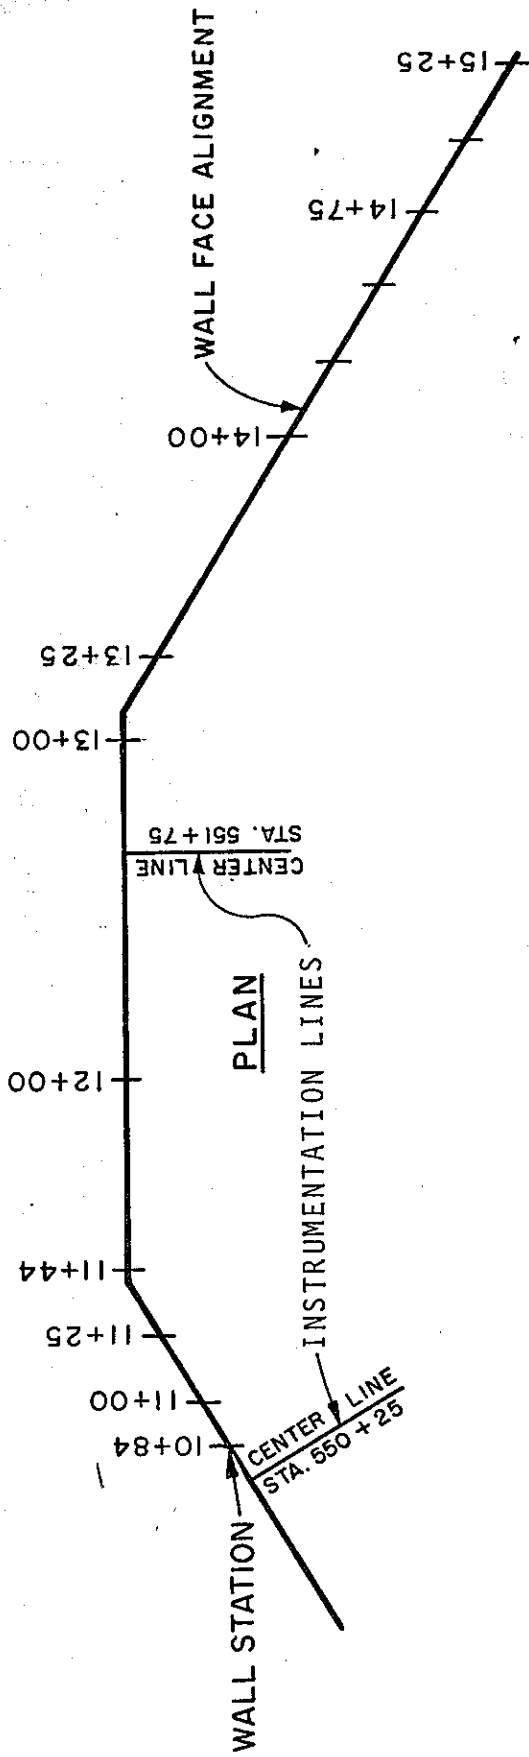
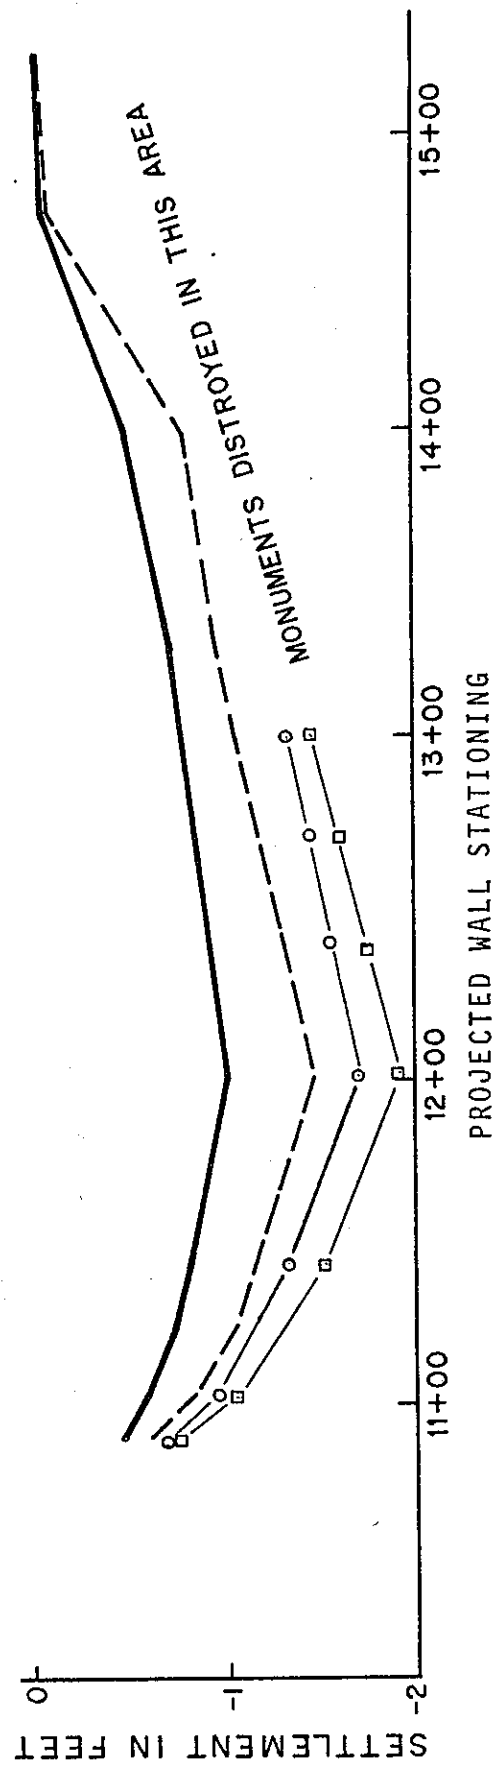
FIGURE 13

SETTLEMENTS AT SERIES "C" MONUMENTS

Settlement of the wall has continued since construction. A total settlement of 3.5 ft was recorded on settlement platforms SP1 through SP4 at Sta. 551+75, Level A, through December 1973. (Refer to Figure 8.) The readout at this level was destroyed after that date. Measurements on Series "A" and "C" monuments have provided a continuation of the settlement record. Based on these measurements, about 1.0 ft of additional settlement has occurred through May 1980. Measurements on Series "A" monuments show a maximum of 0.5 ft of settlement between 1973 and 1978 (Figure 12). No settlement measurements are available for Series "A" monuments after 1978 since they were buried by the correctional work. Series "C" monuments at the top of the wall suggest a maximum of 1.0 ft of settlement between 1973 and May 1980 (Figure 13). About 20% of that occurred since 1978.

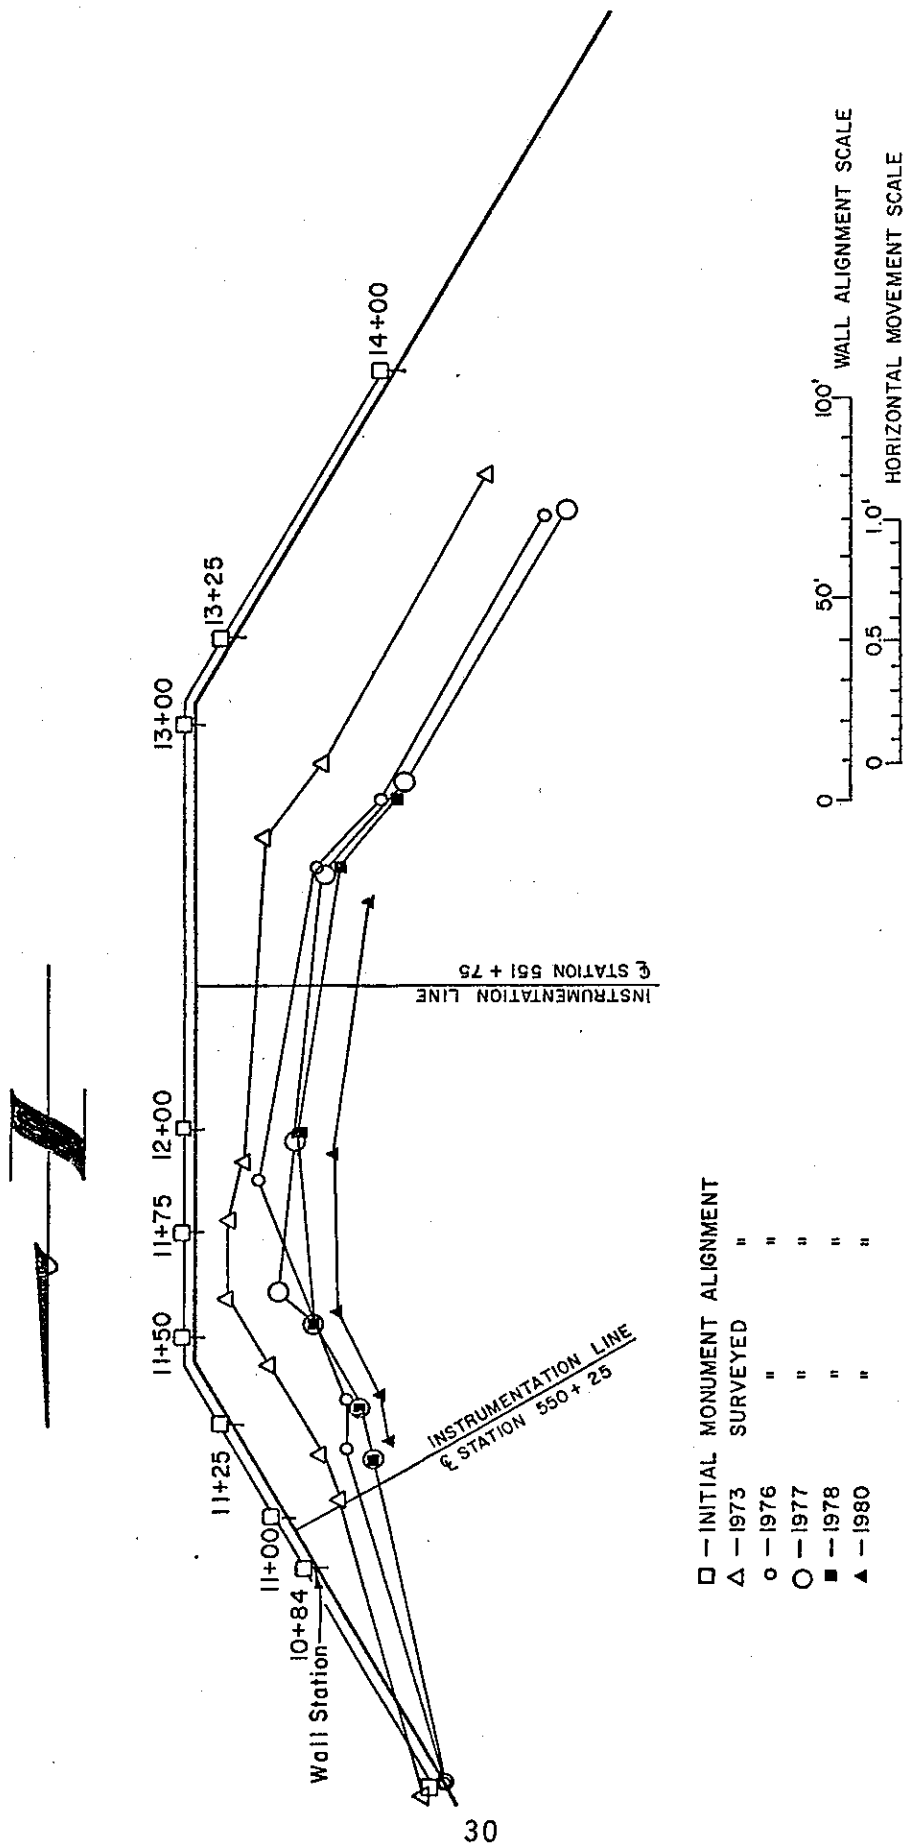
FIGURE II

HORIZONTAL MOVEMENTS AT SERIES "C" MONUMENTS

Measurements made on Series "C" monuments on top of the wall suggest 1.5 to 1.9 inches of additional horizontal movement since 1978 for the north flank and center chord sections of the wall. (Refer to Figure 11 and Table 6.) These measurements represent horizontal movement since 1978, the majority of which probably occurred prior to the correctional work in 1979. The measurements, therefore, do not provide a good assessment of the effectiveness in correcting the overall stability of the wall.

The maximum total recorded horizontal movement was 12.48 inches on May 5, 1980, and also occurred at Sta. 13+00.

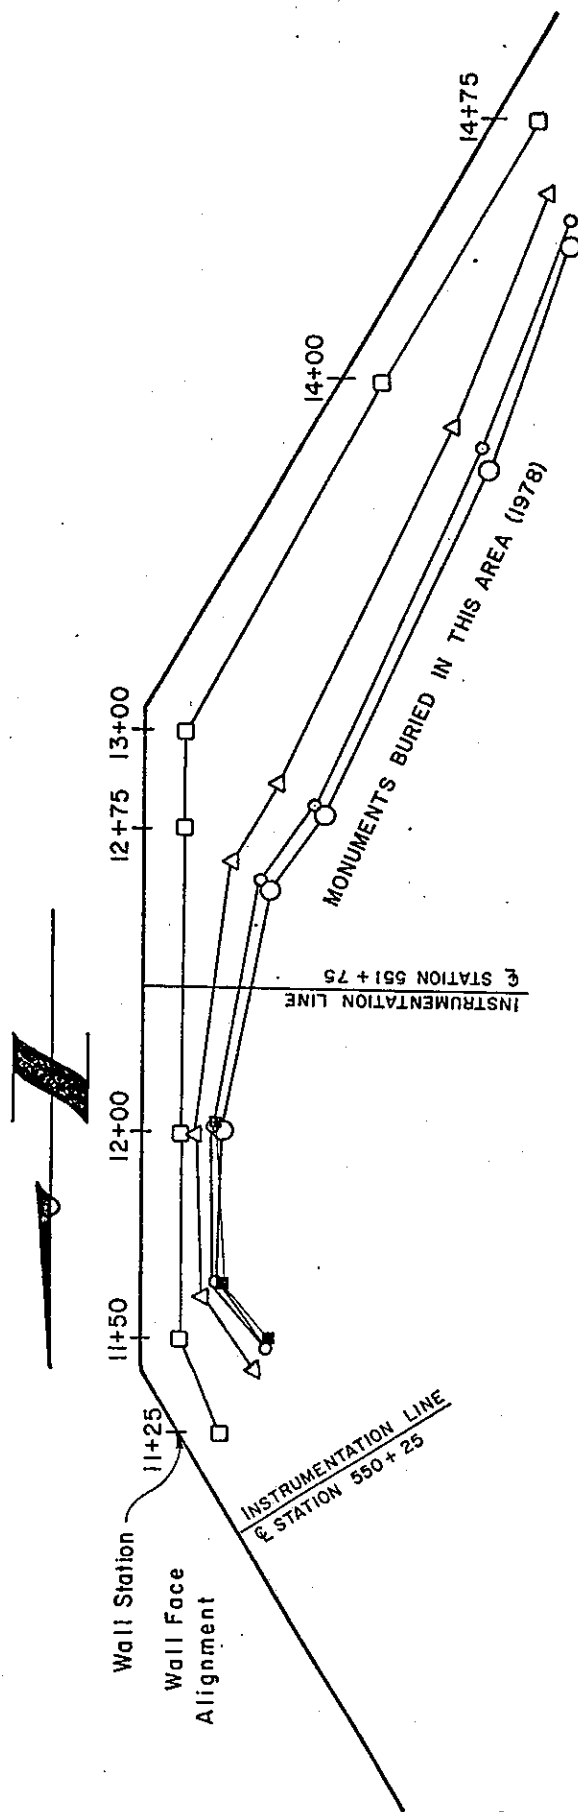
FIGURE 10

HORIZONTAL MOVEMENTS AT SERIES "A" MONUMENTS

recorded horizontal movement was 7.80 inches at Sta. 13+00 on July 1, 1977. (Refer to Figure 10 and Table 5 for measurements through 1978.)

No recent measurements to detect horizontal movement were obtained on the Series "A" monuments at the base of the wall, as they were buried on the south flank by the temporary buttress placed prior to the 1978 measurements. The monuments on the north flank were also buried by the August 1979 slope correction and buttressing. The maximum total
